**ENVIRONMENTAL ASSESSMENT/PCB  
REMEDICATION REPORT**

General Services Administration  
1500 E. Bannister Road  
Room 2101  
Kansas City, Missouri 64131-3088

SCS Engineers  
10401 Holmes Road, Suite 400  
Kansas City, Missouri 64131

November 2003  
File No. 02200070.24

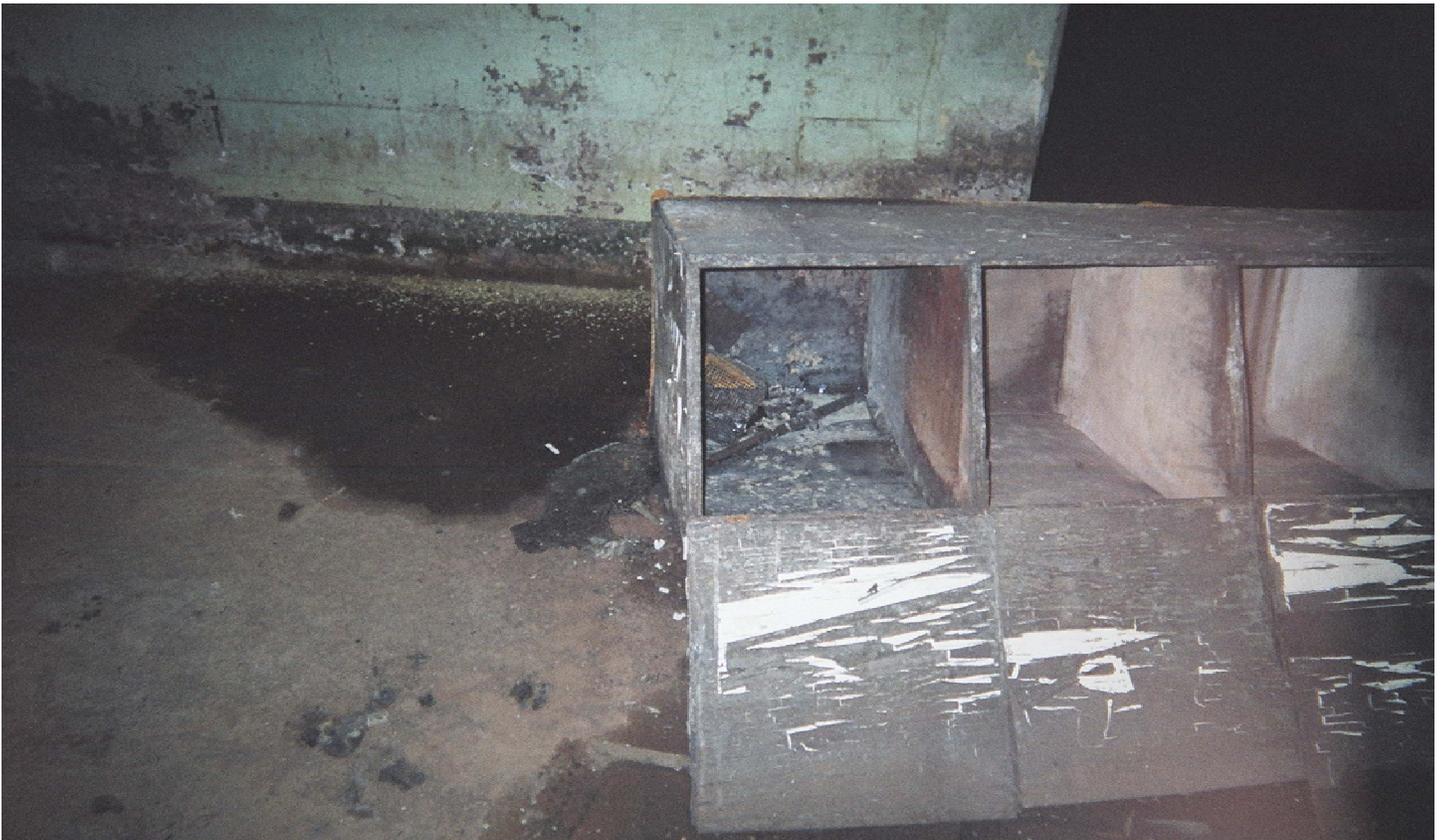
Photograph 1. Building 3, basement, plywood storage box impacted with PCB containing oil.

The impacted areas of the plywood cabinet were dismantled and placed in steel drums. Following remediation of the plywood cabinet, the floor slab in the area where the cabinet was located was cleaned with solvent and thoroughly wiped with spill pads. The floor slab below the

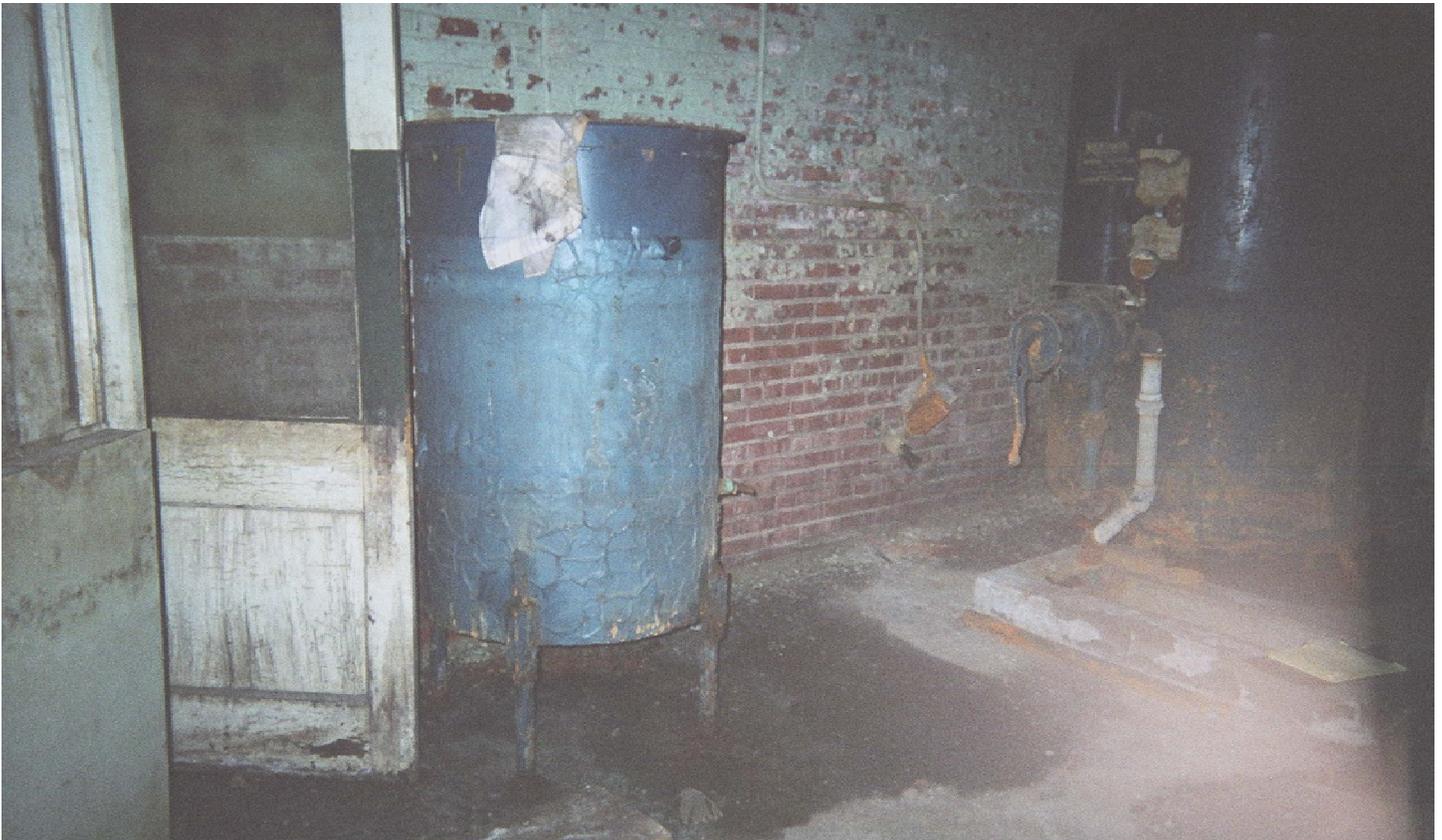
Photograph 2. Building 3, basement, open storage tank.

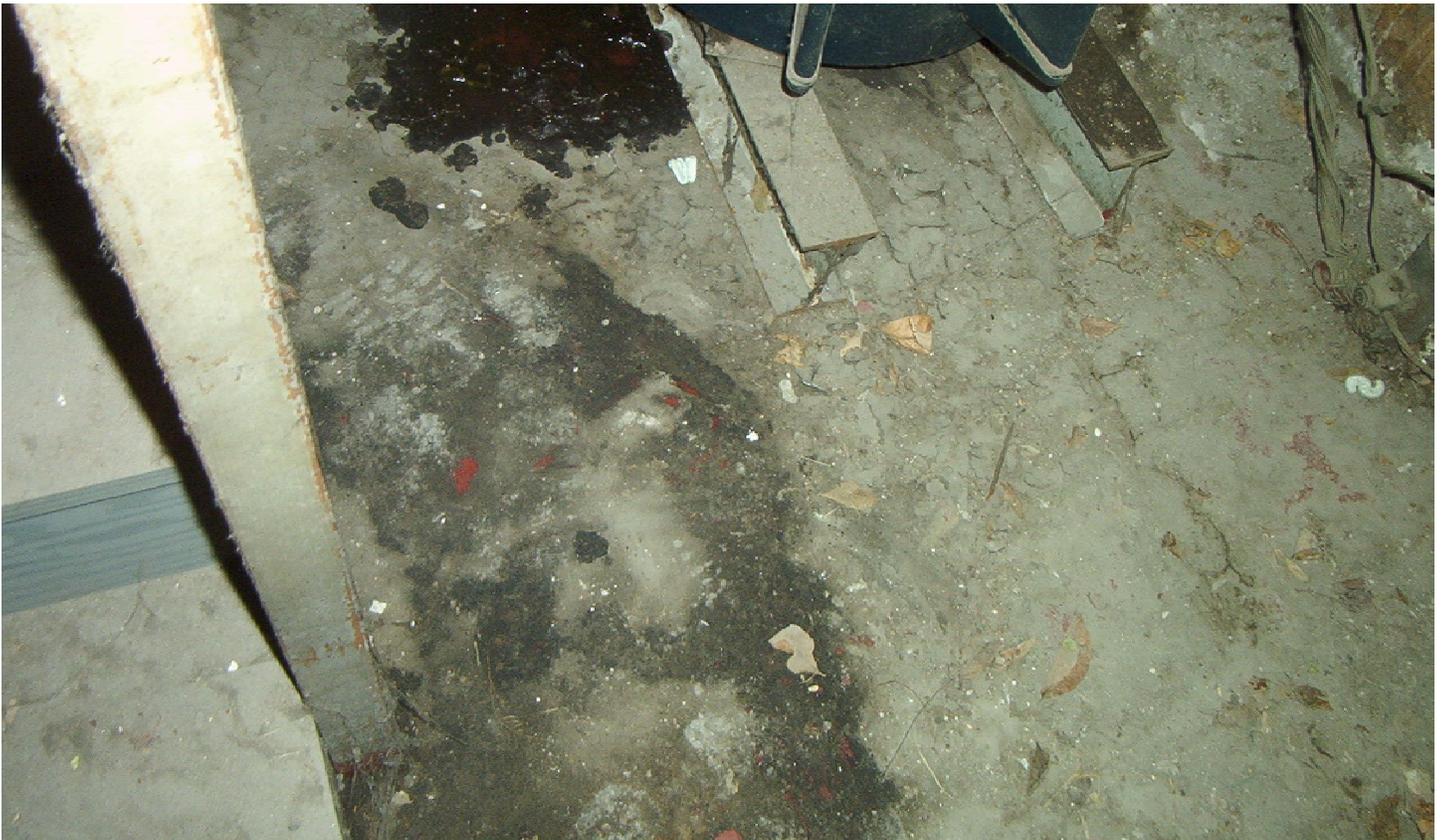
Photograph 3. Building 3, 1st floor, poly transformer oil spill.

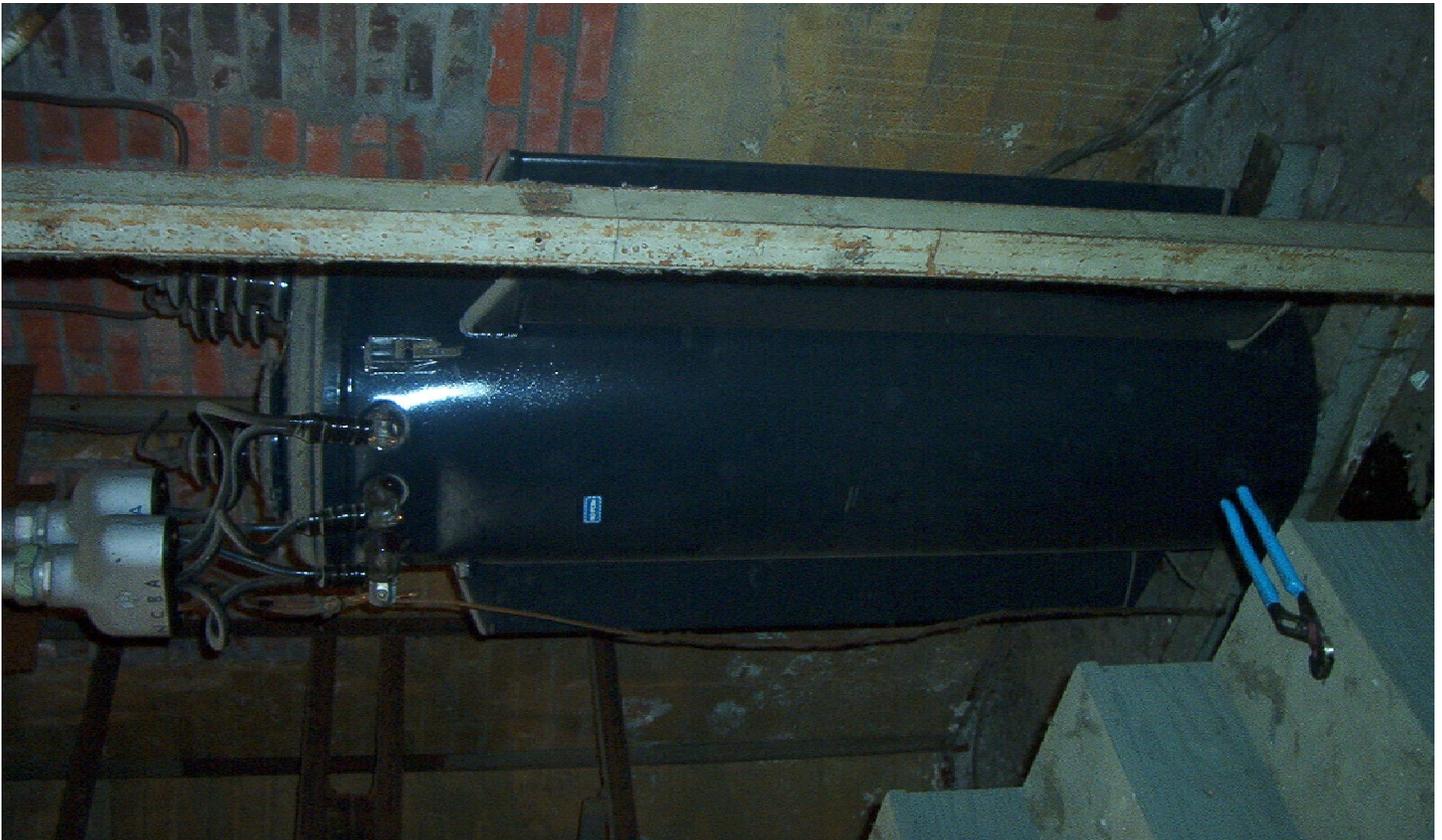
Photograph 4. Building 3, 1st floor, poly transformer.

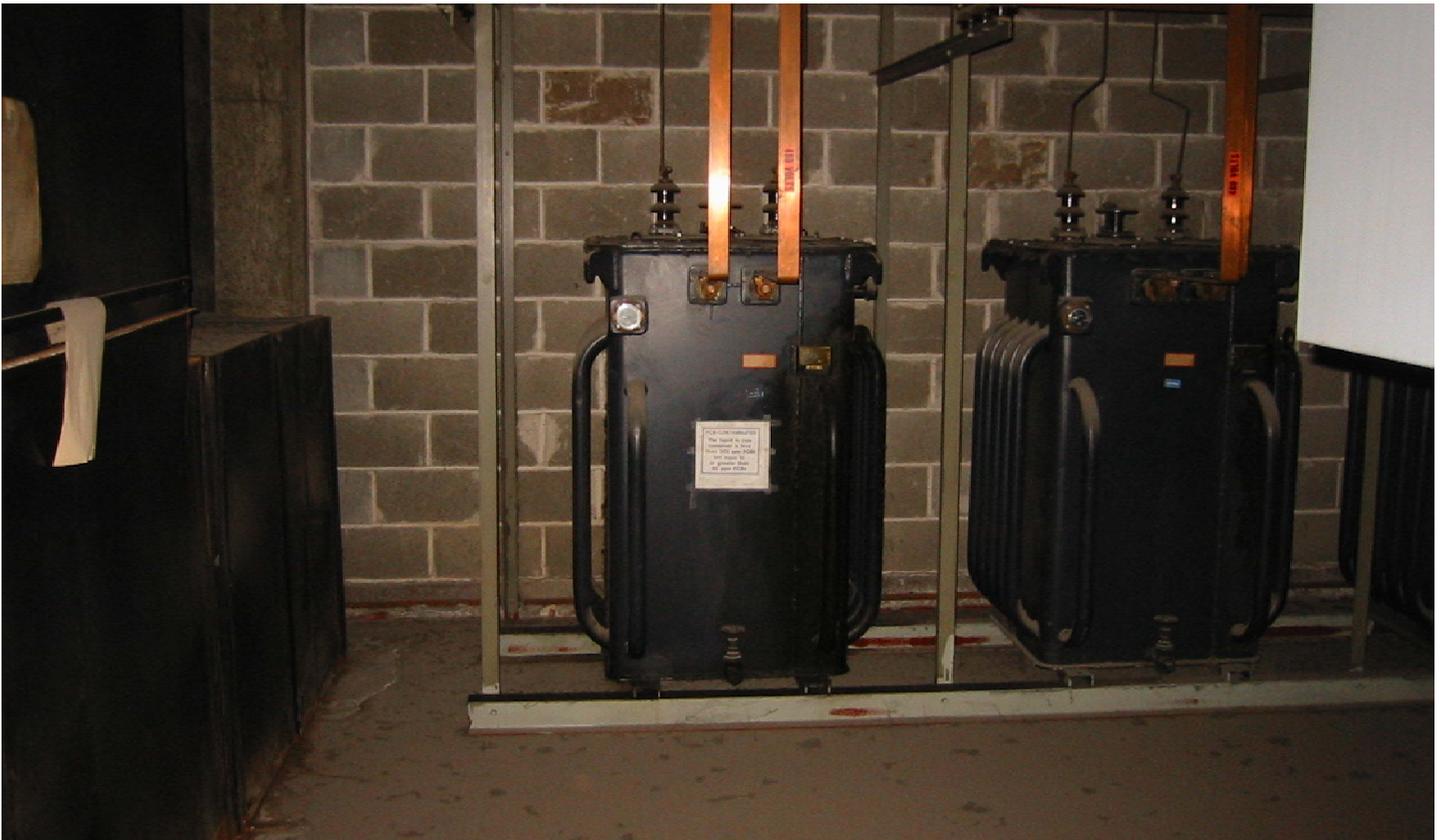
Also located inside the vault room were 3-150 kv transformers, related switch gear, and all exposed electrical wiring and electrical conducting copper busses. Due to the location of the spill area, all electrical equipment in the vault needed to be de-energized prior to accessing the oil pot and mounting/support bracket. However, high voltage power was delivered to the electrical vault and the entire complex of buildings from Building 13. Based on the logistics of de-energizing the entire complex and the size of the oil pot spill and area affected, it was determined that the area would not be cleaned.

Photograph 5. Building 10, basement transformer room that contains 3 transformers.

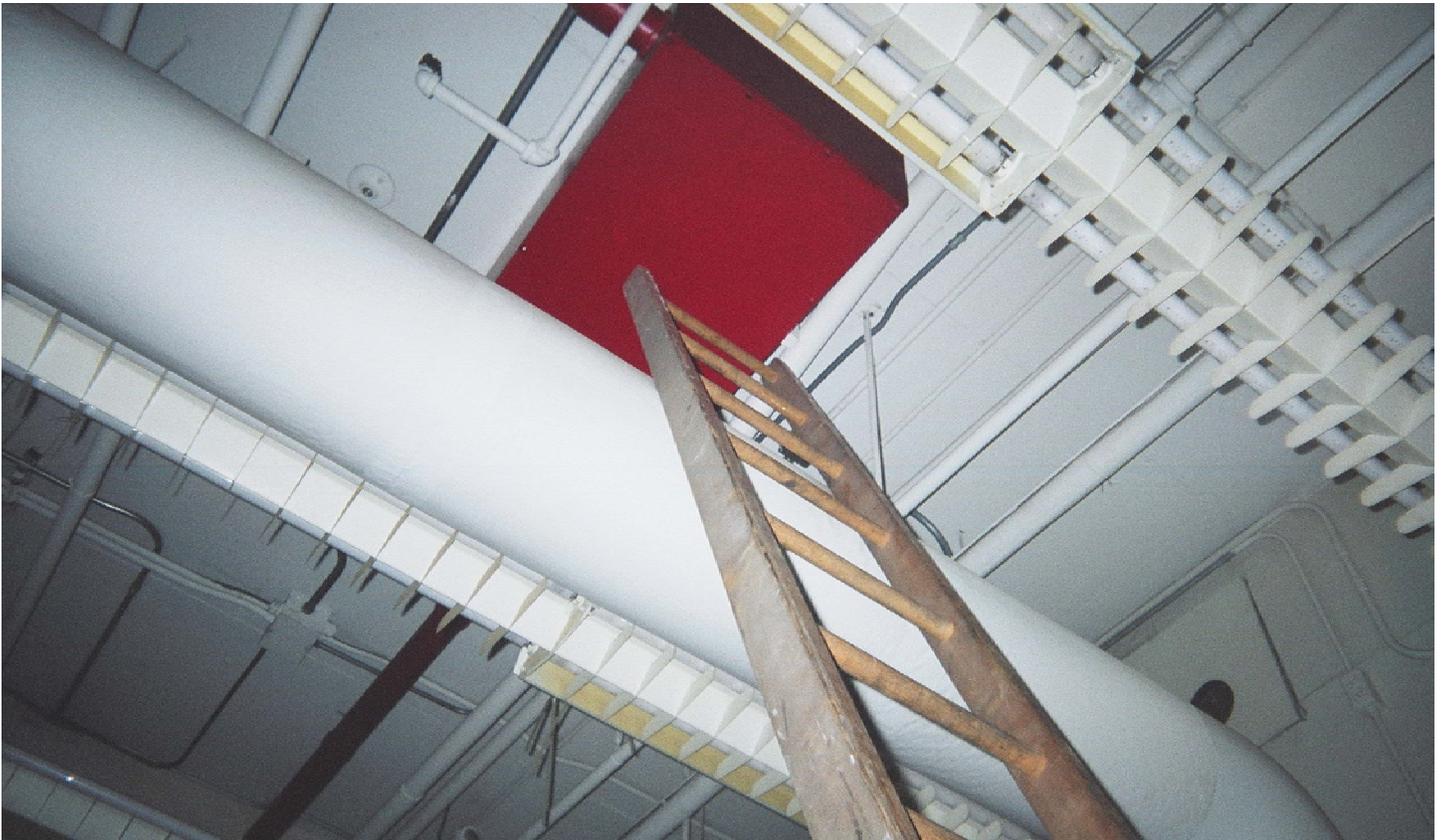
A pull box containing high voltage electrical cable was identified as having an oily PCB containing residue coating the exterior surfaces. The pull box was suspended from the ceiling and leakage was also observed on the floor tiles below. Analysis of wipe samples collected from the pull box and floor tiles below indicated PCB concentrations of 200 ug/wipe and 26 ug/wipe, respectively. The electrical contractor verified the pull box did not have an electrical charge and the remediation contractor used solvent and spill pads to clean the oil from the surface of the pull box. The floor tiles (approximately 6) located below the pull box were also cleaned with solvent and spill pads.

Photograph 6. Building 9, basement, high voltage, pull box.

A post-remediation wipe sample was collected from the cleaned floor tiles below the electrical pull box. This included wiping a 10 cm by 10 cm square area with a laboratory provided sample cloth saturated with hexane. Sample results indicated that PCB concentrations were below laboratory detection limits.

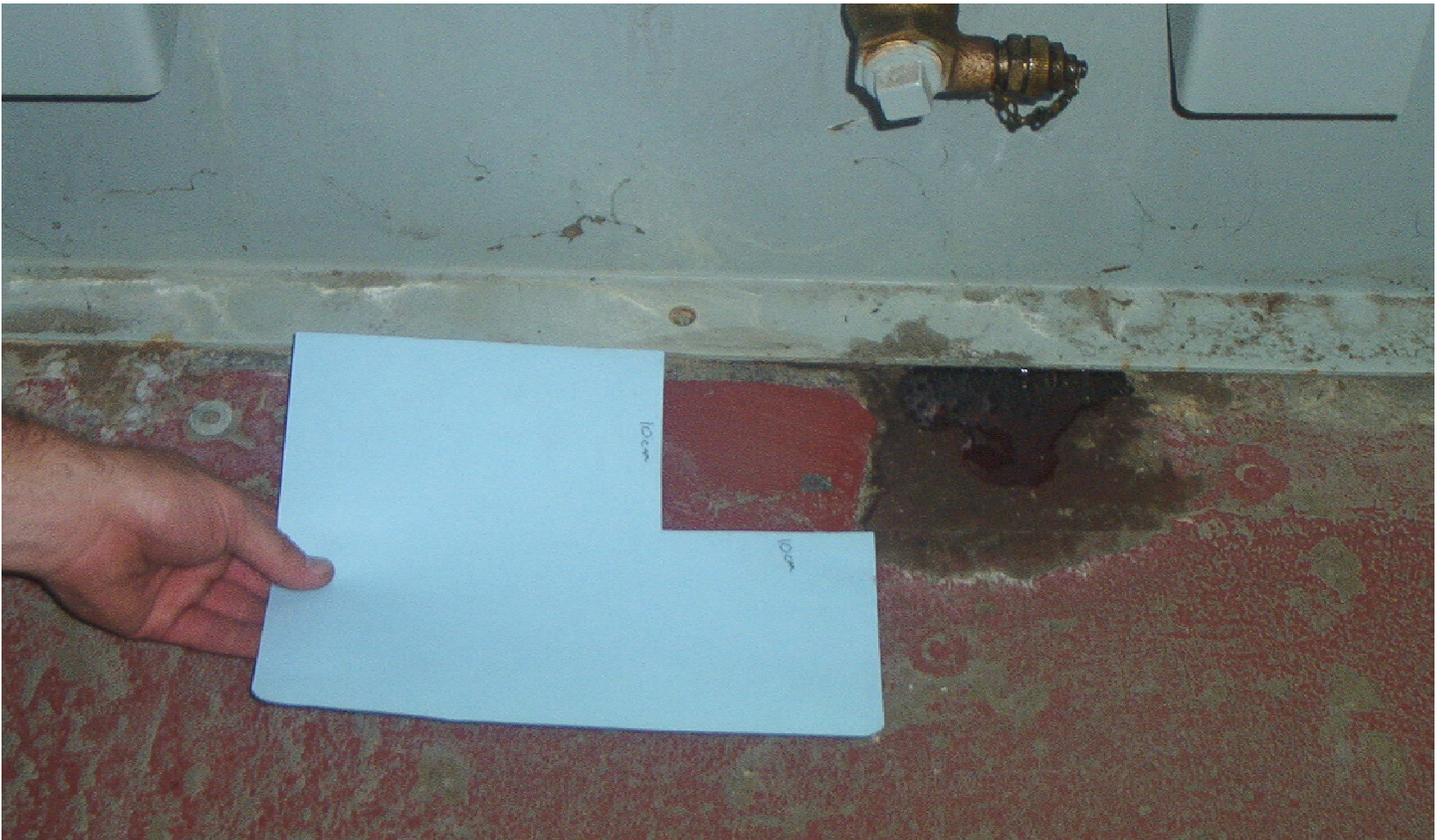
Photograph 7. Building 11, transformer port and containment basin.

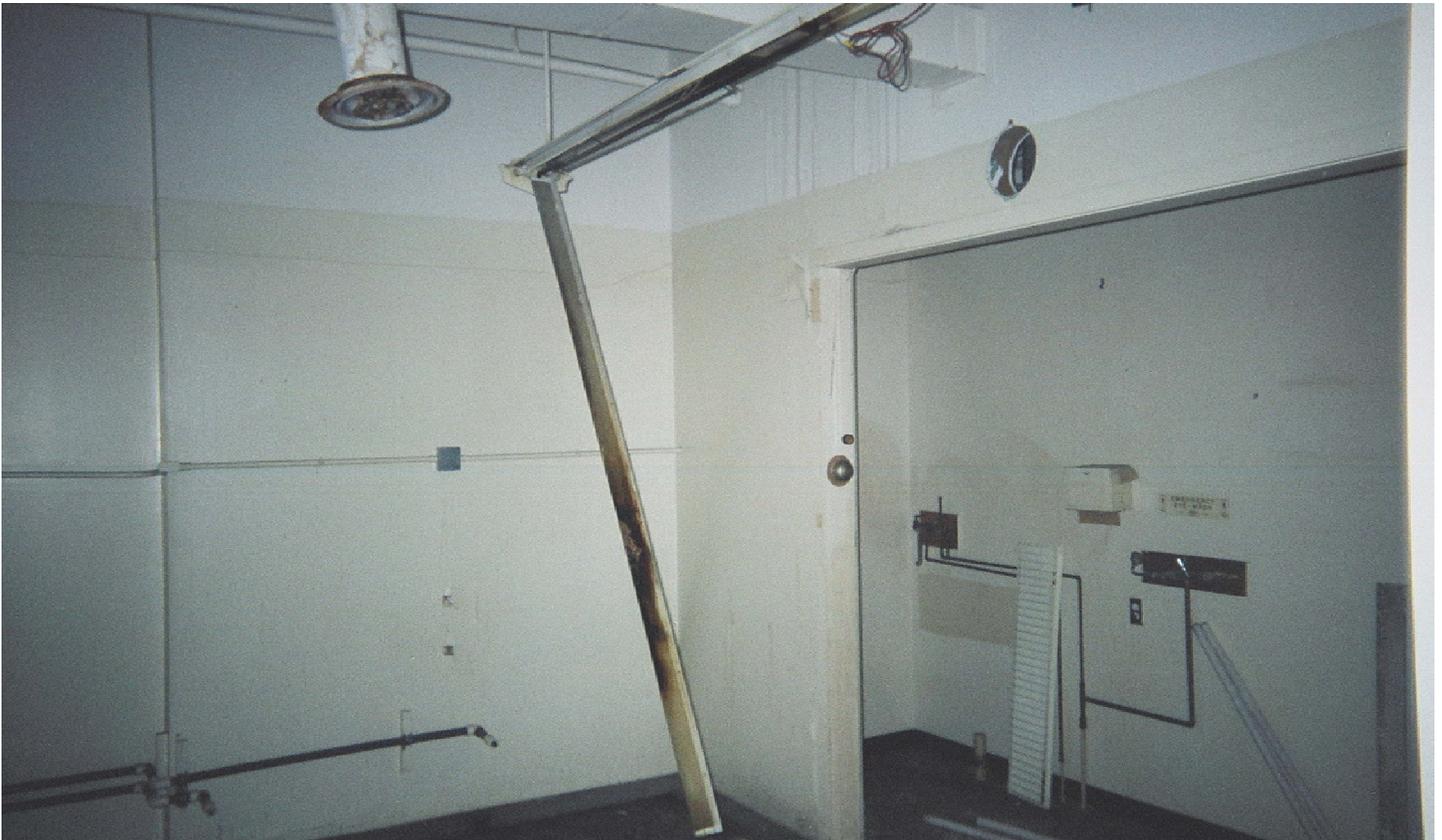
located on the second floor of Building 11 contained 35 ug/wipe and an electrical ballast oil spill located on the first floor of Building 11 contained 33 ug/wipe. Additional cleaning and remediation activities were performed in these areas and subsequent resampling and analysis indicated the areas were sufficiently cleaned. Analytical data was reviewed, separated and placed in tables for each specific building. Copies of these tables can be found in Appendix A. Laboratory analytical data sheets and chain-of-custody documentation can be found in Appendix B.

Photograph 8. Building 11, 1st floor, electrical ballast spill.

As previously discussed in the Post-Remediation Sampling section, laboratory analytical results indicated the need for further cleaning associated with the ballast spill areas in Building 11. Further remediation was completed in both spill areas and an additional wipe sample was collected following the concentrated cleaning effort. Analysis of the wipe samples (labeled first floor ballast spill retest and second floor ballast spill retest) indicated the areas were sufficiently cleaned.

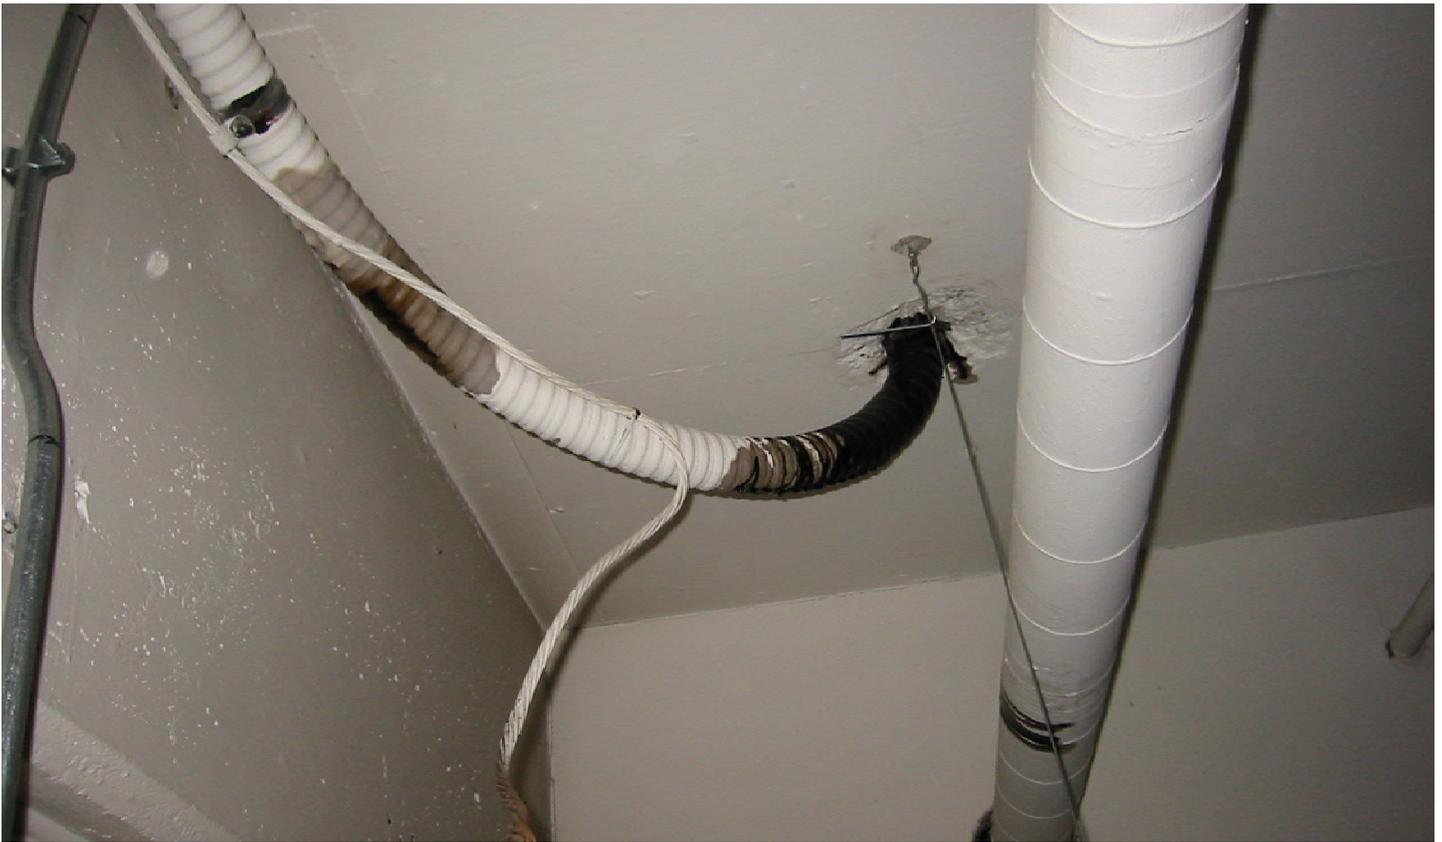
The main spill area was identified on the first floor of the building. A high voltage oil filled cable extending from electrical switch-gear located on the second floor to electrical switch-gear located in the basement had leaked. Spillage from the termination point within the second floor switch-gear had impacted the second floor concrete slab. Further migration of the oil along the high voltage cable resulted in spillage on first floor suspended ceiling tiles and framework, drywall, and floor tiles. Analysis of a wipe sample collected from the supporting beam indicated PCB concentrations of 2.2 ug/wipe. The high voltage electrical system in Building 11 was de-energized and the leaking high voltage cable was removed by the electrical contractor. The remediation contractor constructed the necessary containment and provided proper PPE. The cable (approximately 105 feet in length) was cut into sections measuring approximately three feet in length. Once cut, the cable was placed into steel drums and labeled for transport to a disposal facility. An oil pot located within the second floor switch gear was also identified as leaking and was removed. Following removal of the cable and oil pot the remediation contractor dismantled and disposed of impacted sections of the suspended ceiling tiles and framework. Approximately 80 square feet of impacted drywall and a section of floor tile and mastic measuring 5 feet by 5 feet were also removed. Impacted building materials were immediately placed in steel drums and were labeled for transport to a disposal facility. The remediation contractor also cleaned the inside of the second floor switch-gear enclosure and the surface of the

Photograph 9. Building 11, 1st floor, high voltage cable spill.

concrete floor slab inside the enclosure. A hammer drill was used to remove impacted concrete from inside the hole where the high voltage cable passed from the first floor to the second floor.

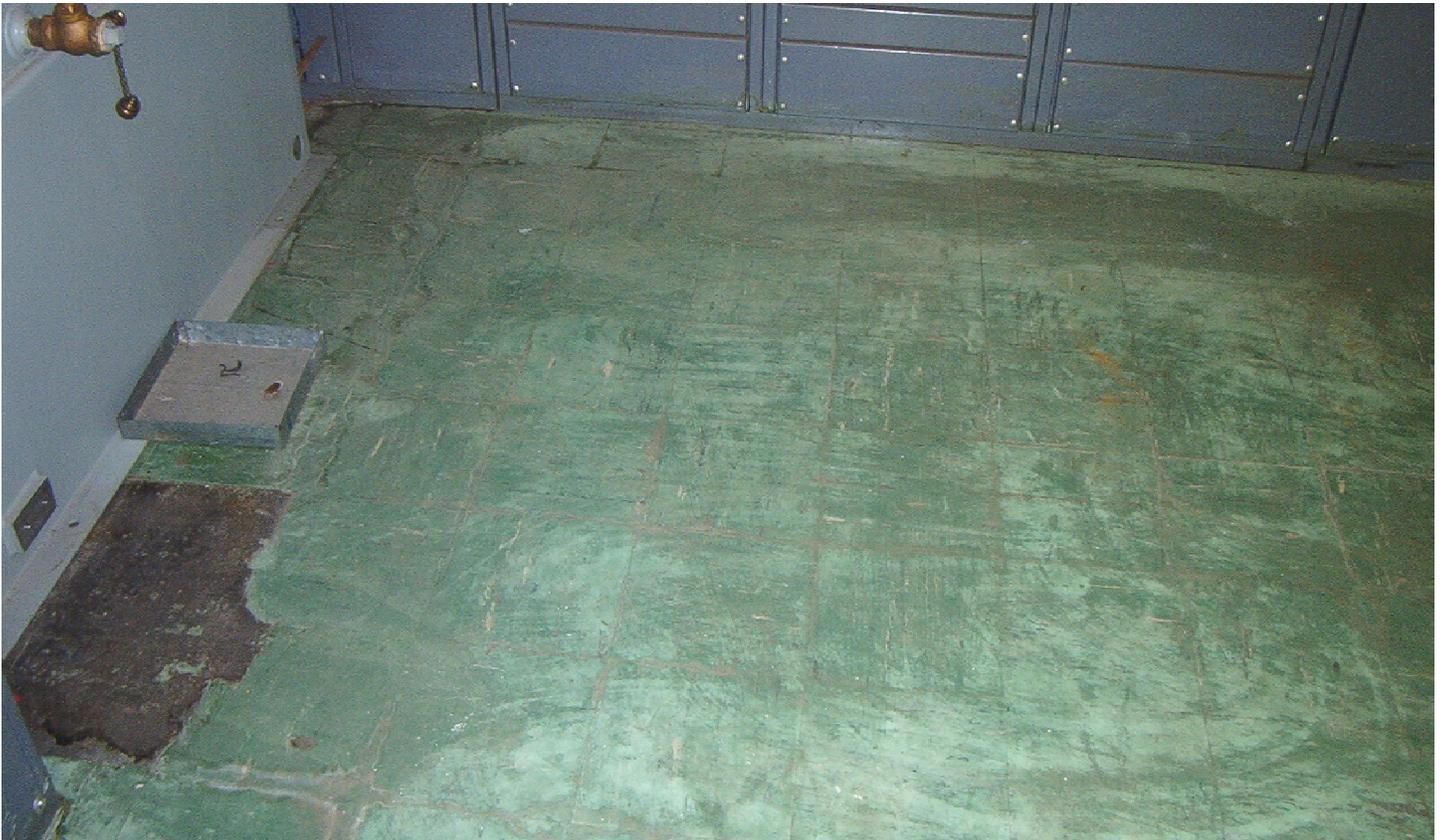
Photograph 10. Building 11, 2nd floor, chiller room transformer containment basin.

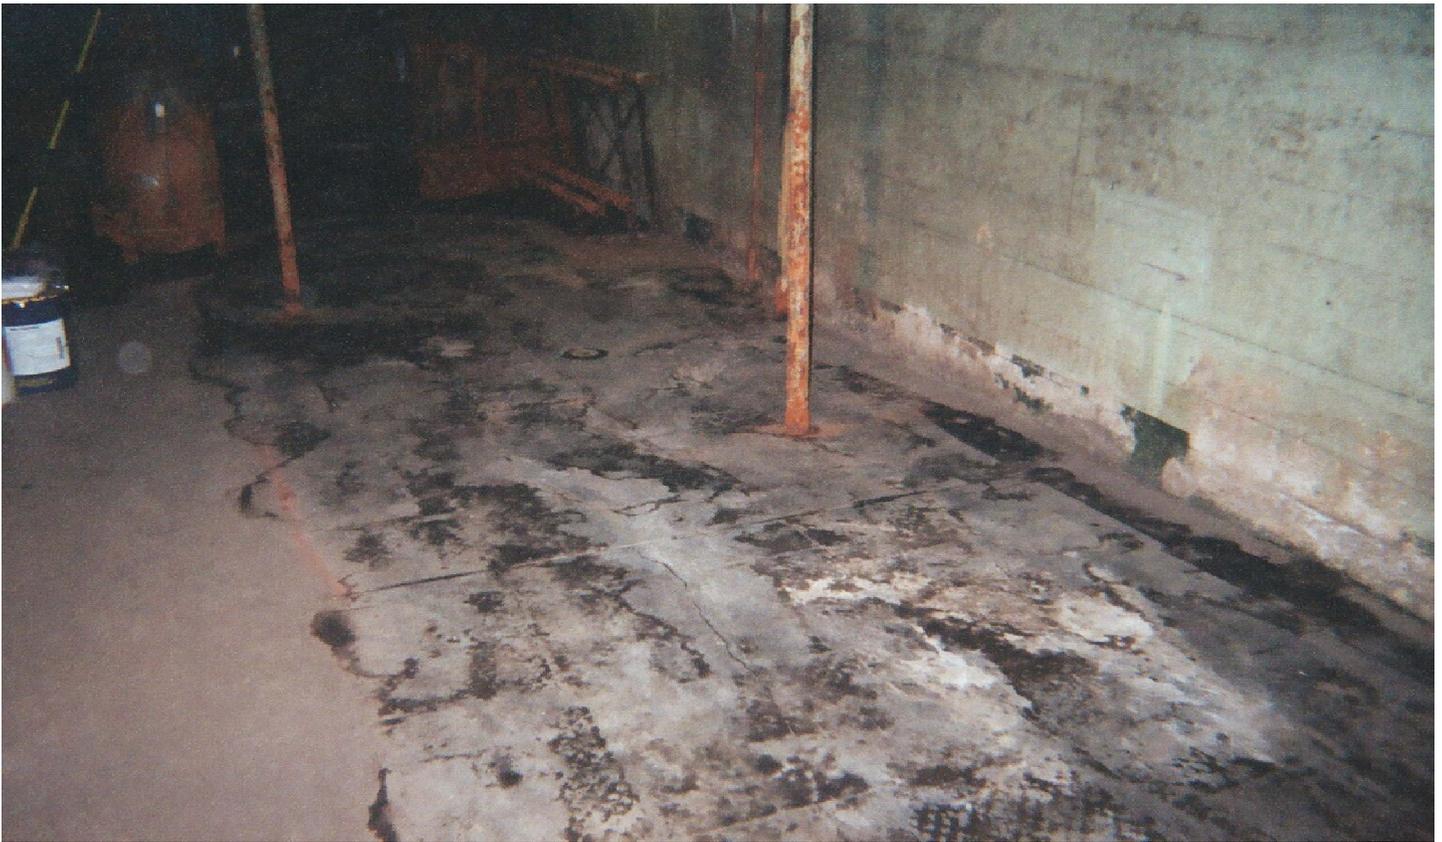
Photograph 11. Building 3, basement, cleaning floor slab below high voltage switch/duct.

electrical switch/duct was swept to remove all loose material that had been deposited from overhead equipment. Solvent and spill pads were used to lift and remove all remaining material from the slab. All material removed from the floor slab and disposable spill pads utilized for cleaning the slab areas were containerized in drums and were transported off-site under manifest for proper disposal.

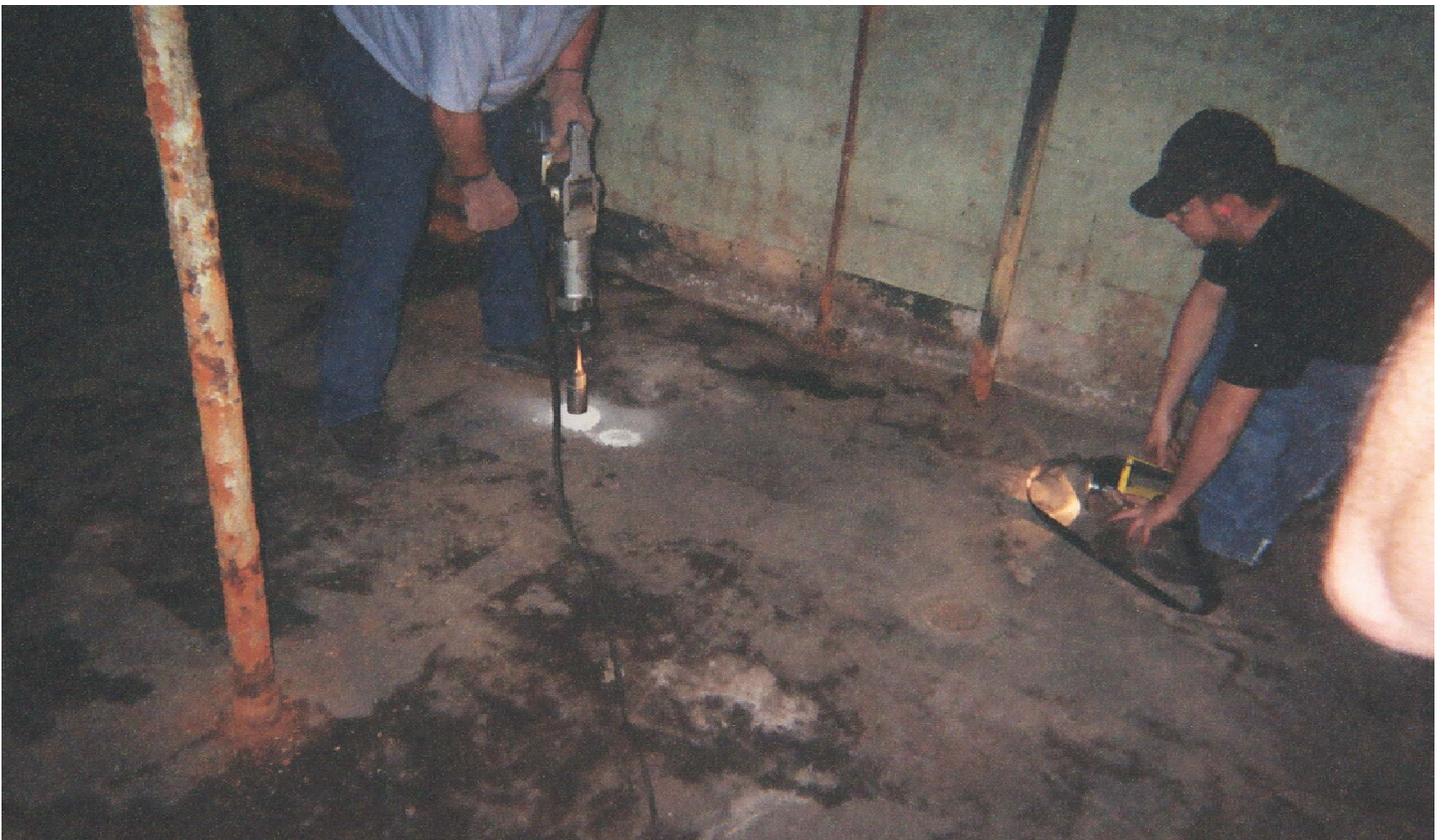
Photograph 12. Building 3, basement, collecting concrete core sample for PCB analysis.

Post-remediation wipe samples and concrete samples were collected from the cleaned areas. This included collecting a core sample from the floor slab located directly below the high voltage electrical switch/duct and the floor slab area where the plywood cabinet was located. All core samples collected extended from the surface of the floor slab to a point approximately 3 inches into the slab. A post-remediation wipe sample was collected from the cleaned floor area below the electrical equipment brace in the first floor electrical vault and also from cleaned floor below the electrical switch/duct located in the basement. This included thoroughly wiping a 10 cm by 10 cm square area with a laboratory provided sample cloth saturated with hexane. PCB analysis of wipe samples collected from the basement floor below the electrical switch/duct and from the floor in the transformer vault were below laboratory detection limits. Analysis of concrete core samples collected from the basement floor slab below the electrical switch/duct and from the basement floor slab area where the plywood cabinet was located indicated PCB concentrations of 49 ug/kg and 81 ug/kg, respectively.

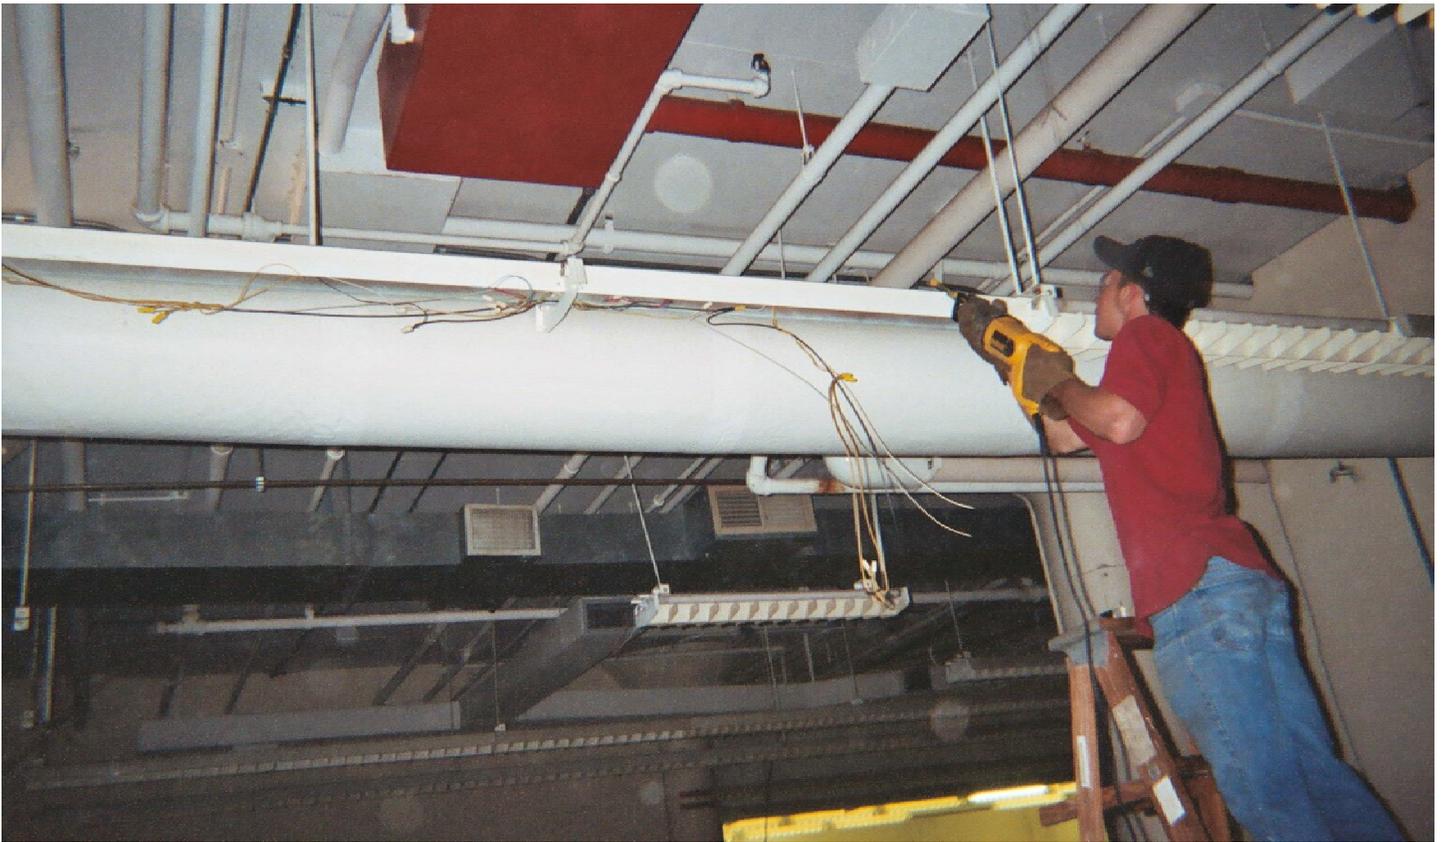
Photograph 13. Building 9, basement, removing fixtures with leaking electrical and ballasts.

A total of 56 light fixtures with leaking ballasts were identified in Building 9. The electrical contractor disconnected power sources at junction boxes and the remediation contractor constructed the necessary containment and provided proper PPE. All fixtures were removed from the building and were stockpiled on and were covered with plastic to prohibit contaminant migration. All light bulbs were removed from the fixtures and were packed in cardboard boxes for shipment to a recycling facility. Shipment of the light fixtures was completed by palletizing stockpiled fixtures under containment conditions and loading them onto a delivery van/truck.

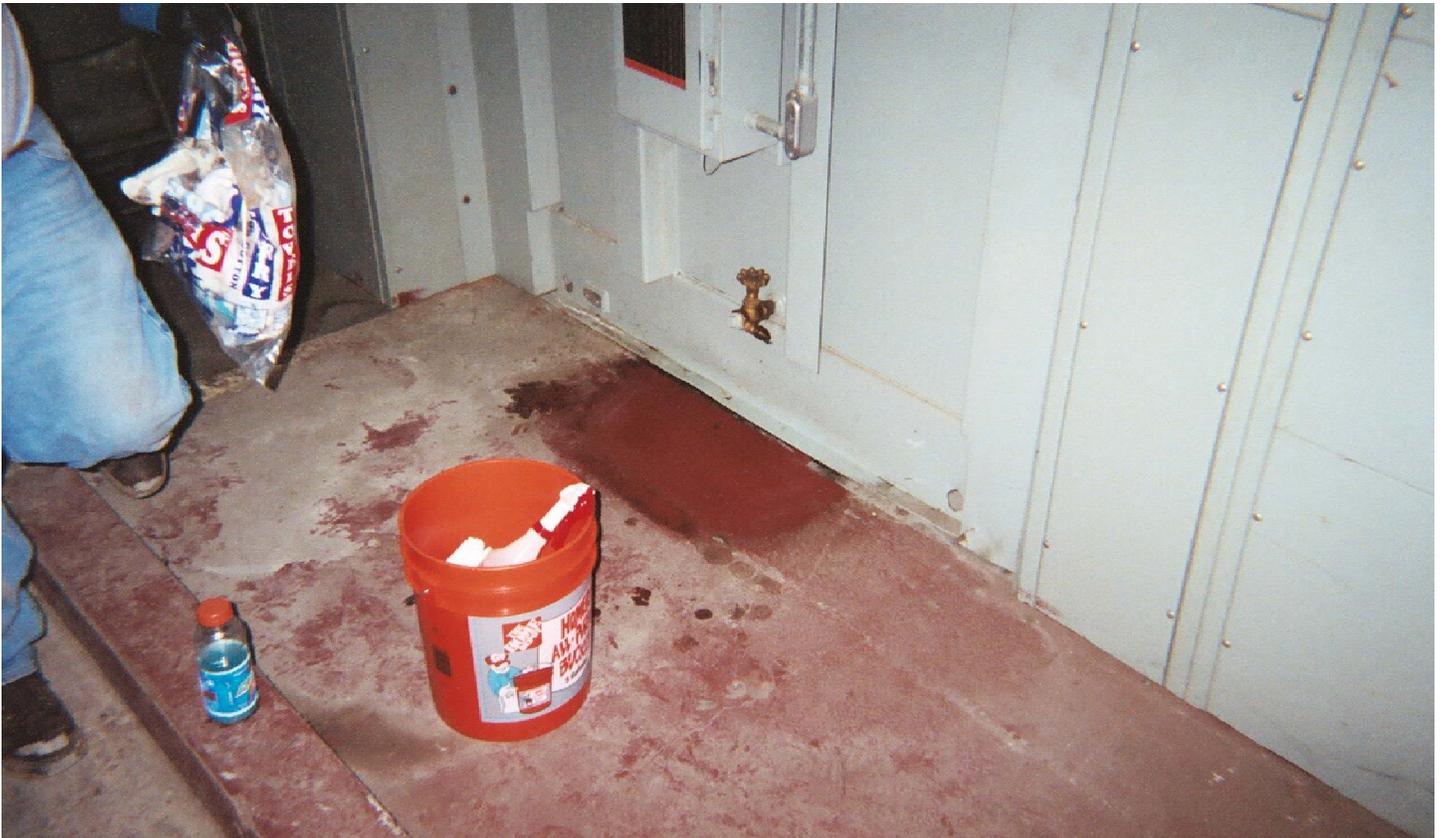
Photograph 14. Building 11, basement, transformer park and containment area following remediation

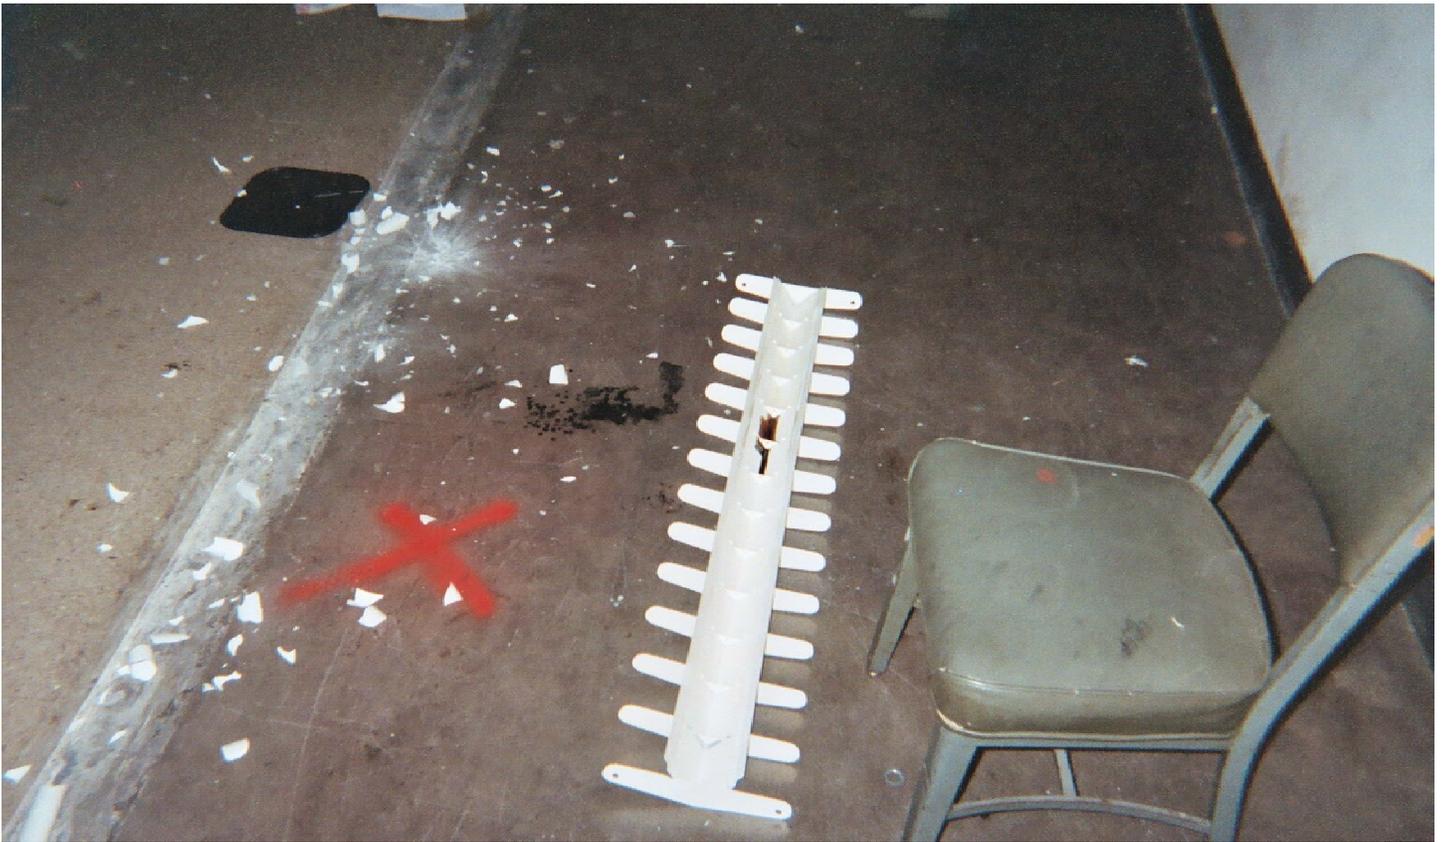
Photograph 15. Building 11, 1st floor, ballast spill.

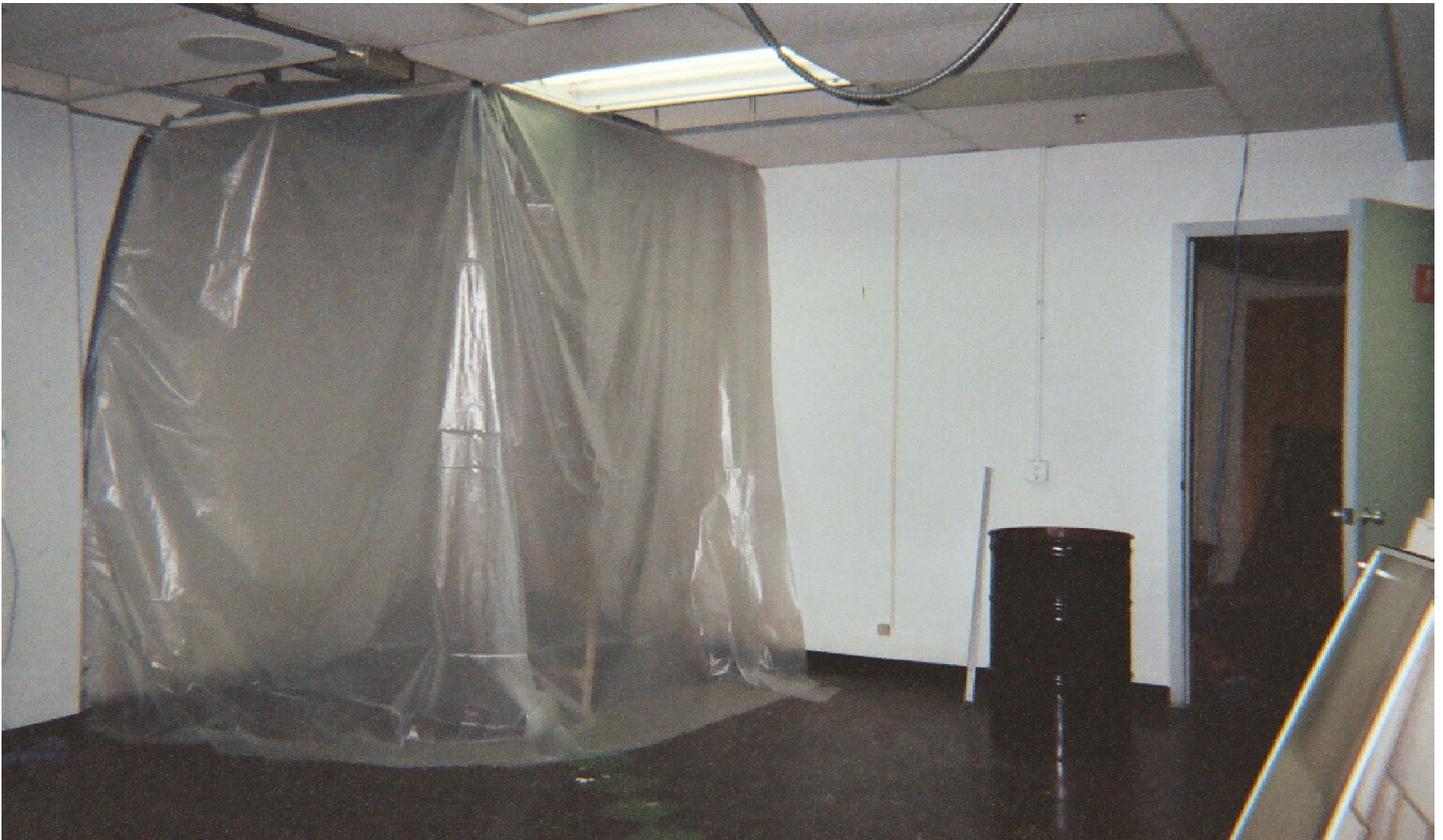
Photograph 16. Building 11, 1st floor, removing PCB impacted building materials.

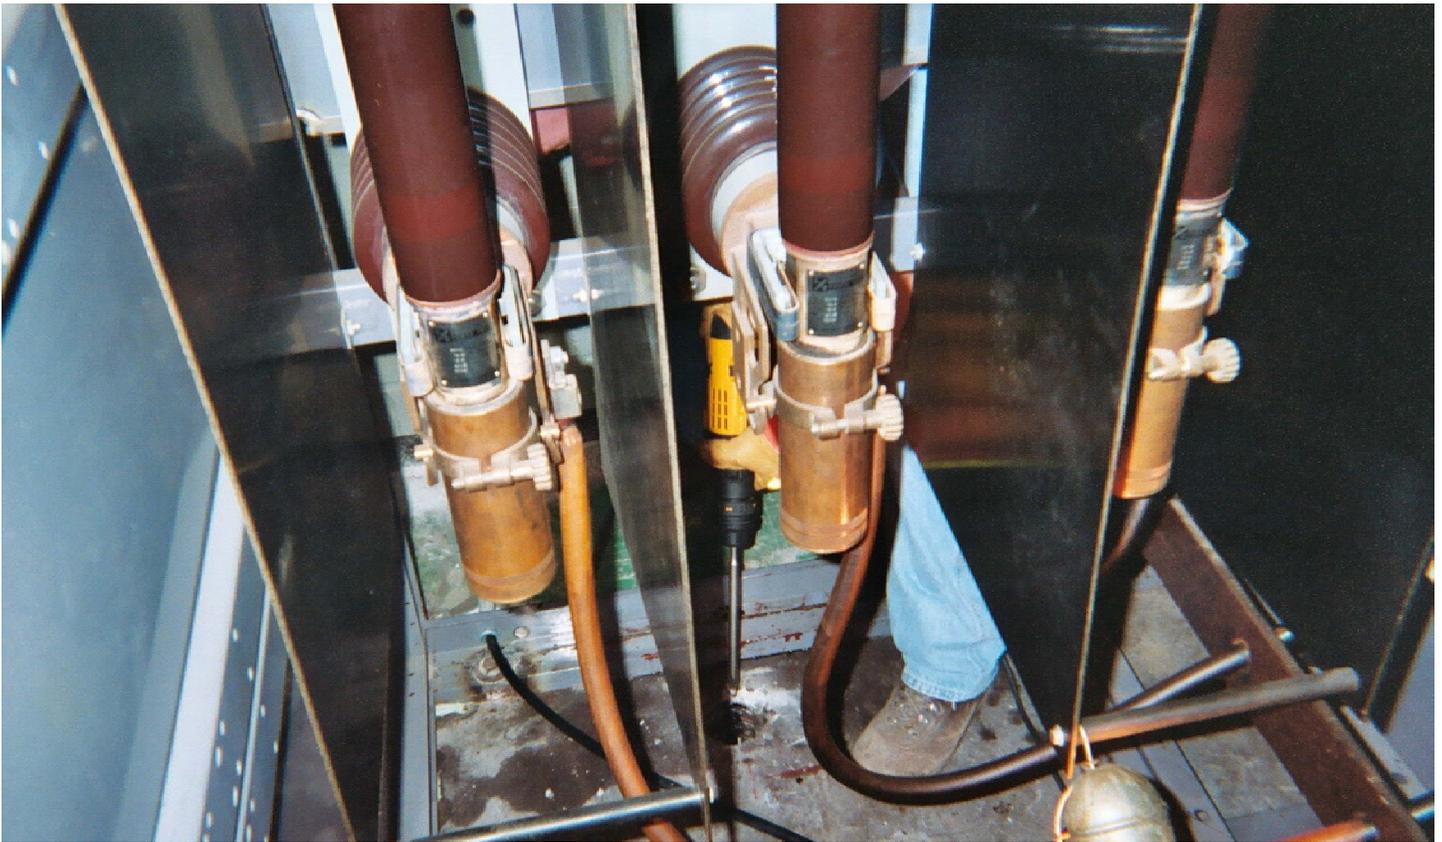
Photograph 17. Building 11, 2nd floor, removing PCB impacted concrete for disposal.
