**ENVIRONMENTAL ASSESSMENT/PCB  
REMEDICATION REPORT**

General Services Administration  
1500 E. Bannister Road  
Room 2101  
Kansas City, Missouri 64131-3088

SCS Engineers  
10401 Holmes Road, Suite 400  
Kansas City, Missouri 64131

November 2003  
File No. 02200070.24

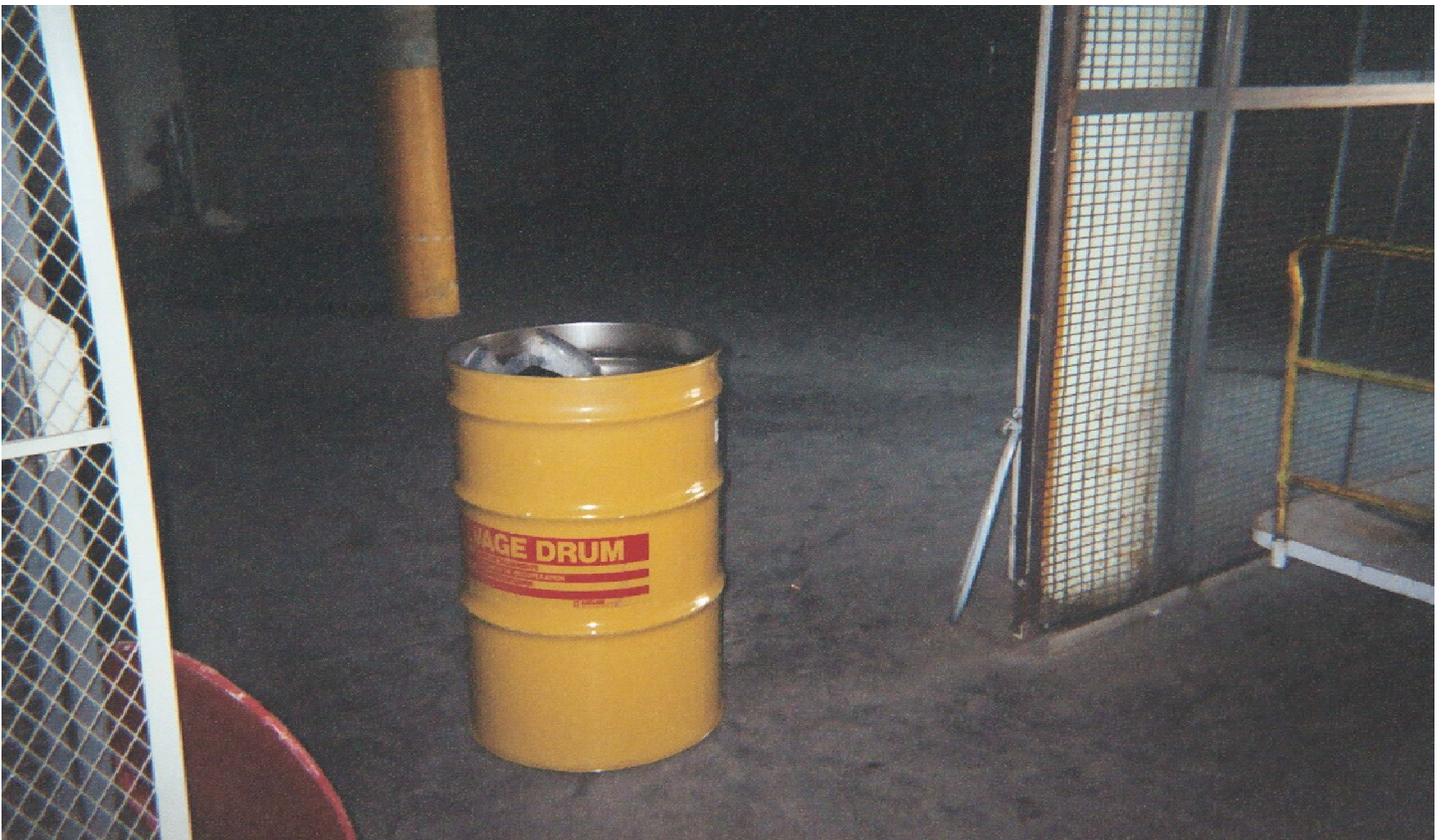
Photograph 18. Building 11, 1st floor, 85-gallon drum with electrical equipment containing PCBs.

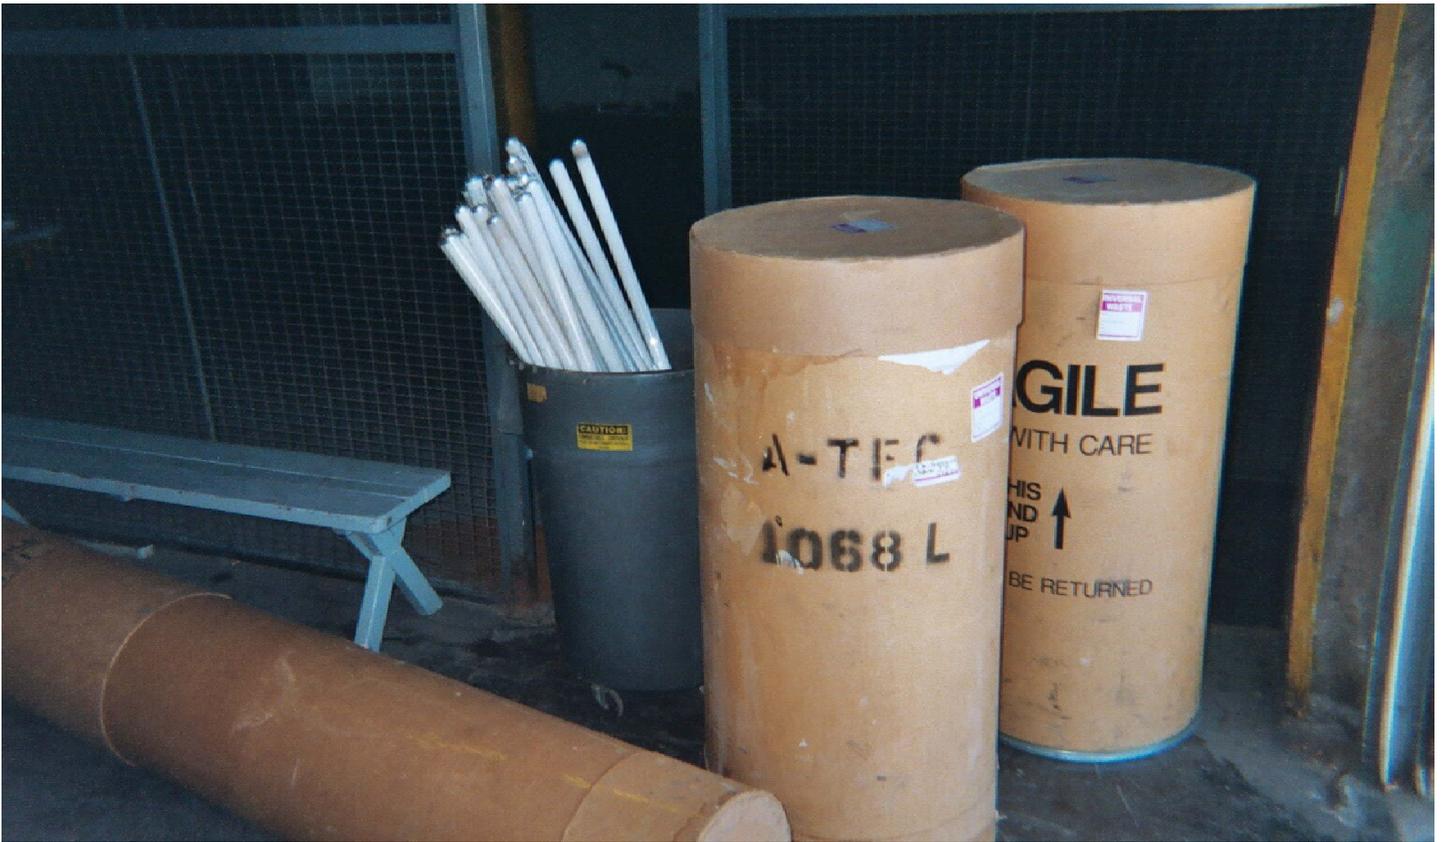
Photograph 19. Building 11, 1st floor, 4 and 8 fluorescent lamps to be recycled.

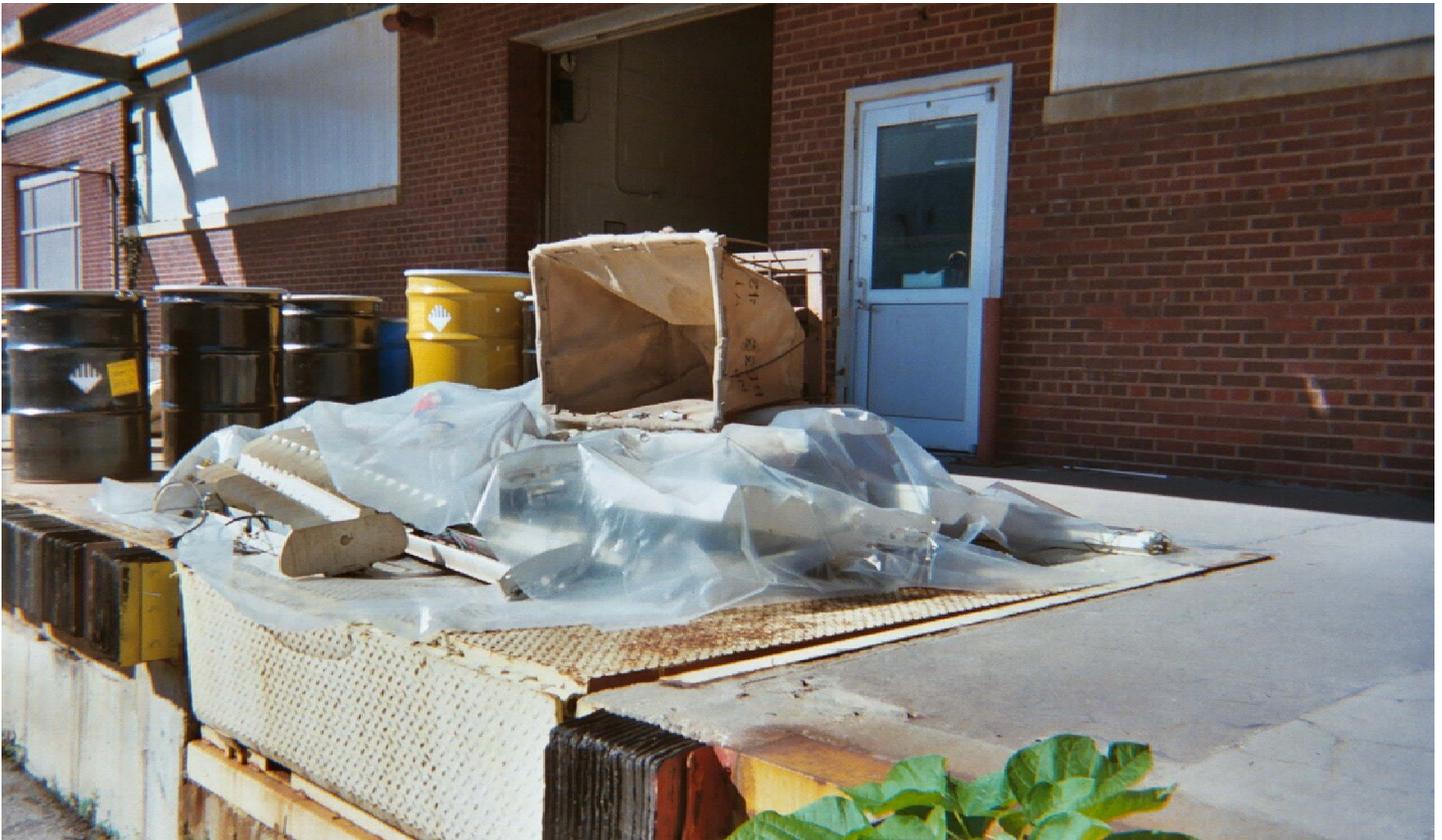
Photograph 20. Building 11, 1st floor, drums and fixtures stockpiled for disposal.

A total of 27 light fixtures with leaking ballasts were identified in Building 11. The electrical contractor disconnected power sources at junction boxes and the remediation contractor constructed the necessary containment and provided proper PPE. All fixtures were removed from the building and were stockpiled on and were covered with plastic to prohibit contaminant migration. All light bulbs were removed from the fixtures and were packed in cardboard boxes for shipment to a recycling facility. Shipment of the light fixtures was completed by palletizing stockpiled fixtures under containment conditions and loading them onto a delivery van/truck.
